Failure Analysis of Polypropylene Used in a Hot Water Environment – Effect of Different Stabilizer Systems

Dale B. Edwards, Bodycote Materials Testing Group
Lawrence J. Broutman, Bodycote Materials Testing Group
Alan I. Kasner, Bodycote Materials Testing Group

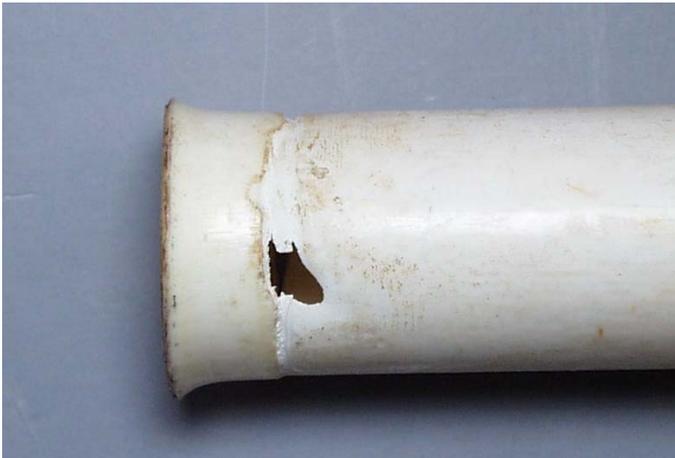
Figure 1. Localized oxidation at point of high stress/turbulence.

Figures 1 through 3 show examples of the types of material degradation failures that were observed. Many of the failed parts exhibited some level of surface oxidation, in some cases very severe. Some samples that were in service for a couple of years did not show severe degradation, while others (likely in more severe environments) showed extensive oxidation. Micro-FTIR spectroscopy was utilized to measure the degree and location of oxidation in the samples. Oxidation of polyolefins, including polypropylene, results in the formation of carbonyl groups onto the polyolefin molecules. These groups have characteristic infrared absorption frequencies. Among these groups, the strongest absorption peak is observed at about 1710 to 1720 cm^{-1} . Weaker peaks are seen at about 1735 and 1775 cm^{-1} . The primary stabilizer compounded into the polypropylene compound has a carbonyl group with a characteristic infrared absorption peak at 1740 cm^{-1} . When oxidation occurs, a peak near 1710 cm^{-1} to 1720 cm^{-1} is formed, which progressively increases in intensity as the degree of polymer oxidation increases. The Carbonyl Index is defined as the ratio of this carbonyl absorbance to that of a polymer absorption band at 1465 cm^{-1} . The use of this ratio compensates for any differences in sample thickness and serves as an internal standard. Carbonyl index values greater than 0.02 indicate significant oxidation. Carbonyl index values for severely degraded material (crumbling) are typically greater than 0.10. The data are shown in Table 1.

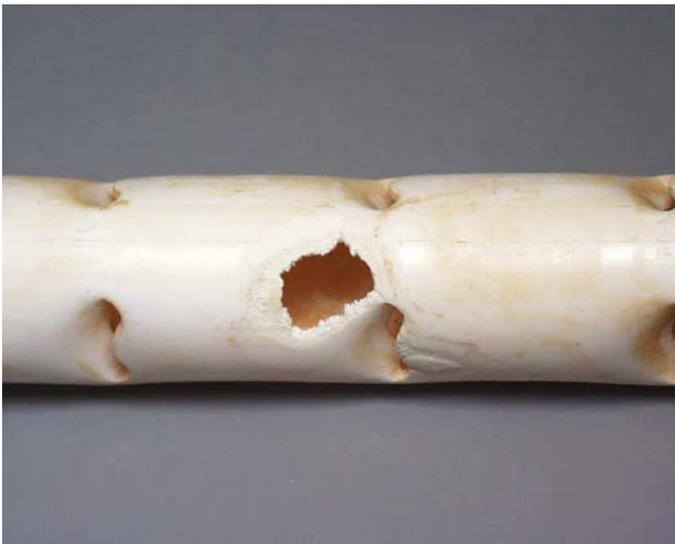
Figure 2. Localized oxidation at point of high stress/turbulence.

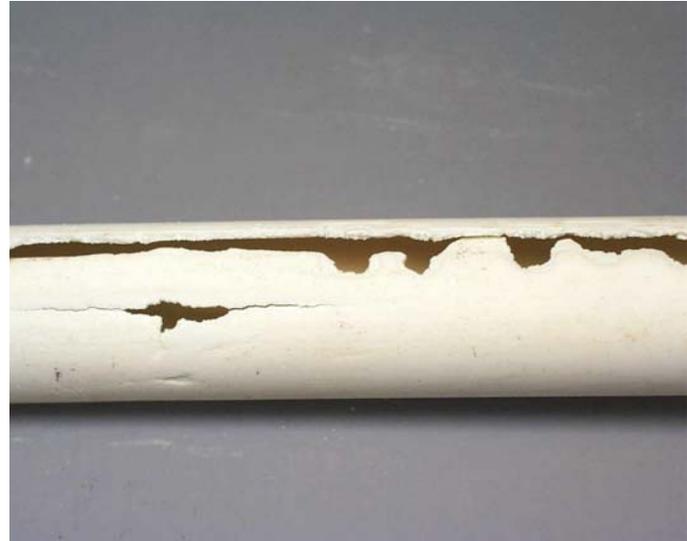
Figure 3. General oxidation and loss of material.

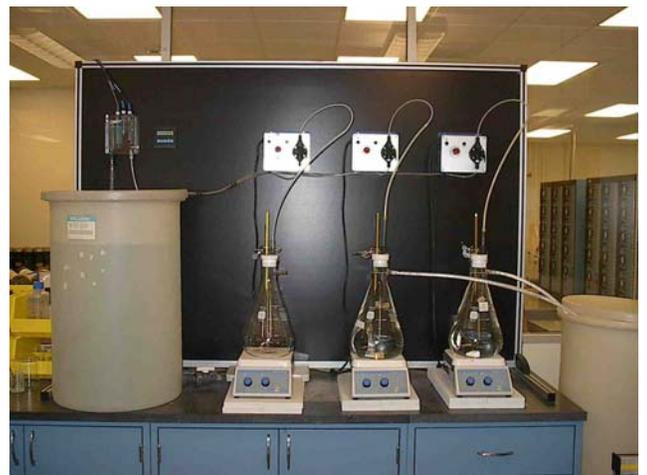
The chlorine water aging was set up with water controlled at 5 ppm chlorine and a pH of 6.8 that was pumped into a stirred flask containing the specimens to be aged. The flow was directed to the bottom of the stirred flask and overflow was allowed to drain out the side arm of the flask into a tank. The aging setup is shown in Figure 4.

Figure 4. Chlorine Aging Bath Setup.

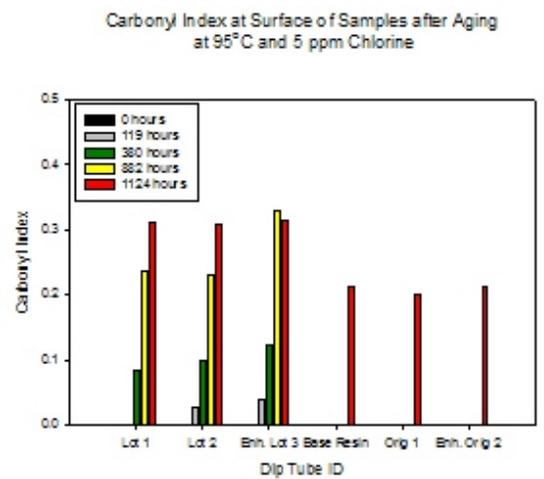
Figures 5 and 6 show the increase in carbonyl index for the surface and core of samples aged in 5 ppm chlorine at 95°C. The data for 85°C aging showed similar results. The new formulation and enhanced formulation became extremely oxidized after exposures between 119 hour and 380 hours. The original formula did not show this level oxidation until approximately 1124 hours. The new formulation samples show significant oxidation after 2000 hours, while the core of the original formulas do not exhibit any oxidation of the core. At this point the original formula parts have residual life, while the new formula parts are beyond the end of their useful life.

Figure 5. Carbonyl Index at Surface after aging at 95°C.

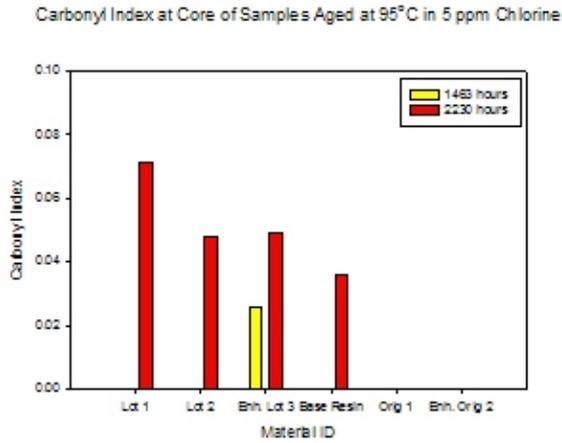
Figure 6. Carbonyl Index at core after aging at 95°C.

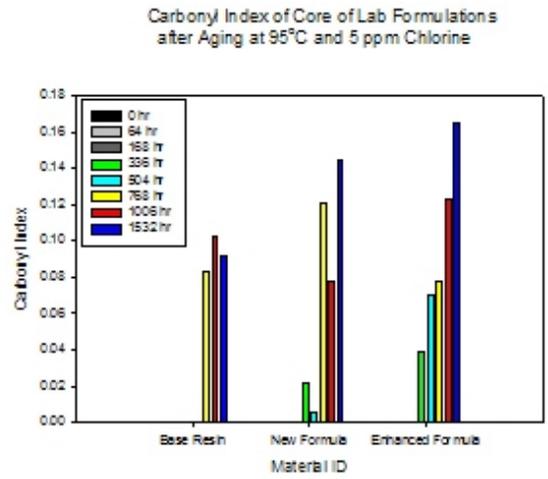
Figures 7 and 8 show the carbonyl index results at the surface and core for aging (95°C/5 ppm Cl) for lab-processed samples of the new formulation, enhanced new formulation and the base resin (having only the primary antioxidant). These results mirror the results from the sample parts, showing that mixing of the formula was not an issue in the deterioration.

Figure 8. Carbonyl index at core of lab processed samples of the new formula after aging at 95°C/5 ppm Cl..

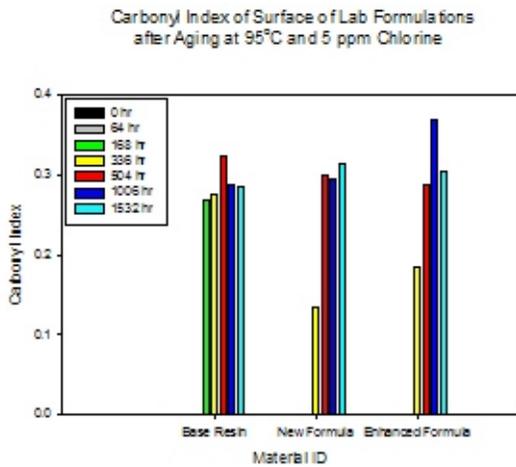
Figure 7. Carbonyl index at surface of lab processed samples of the new formula after aging at 95°C/5 ppm Cl.

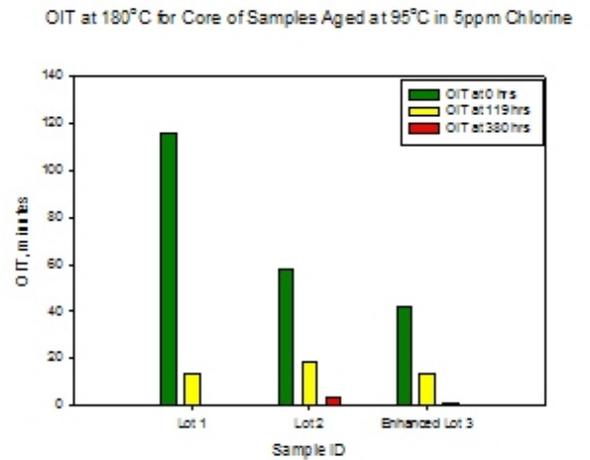
Figure 9 shows the core OIT results for the samples aged in chlorinated water at 95°C. The OIT was measured on the new formulation samples at 180°C in order to get a measurable OIT for the unaged samples. The new formula parts show that the OIT of the surface decreases to near zero between 119 and 380 hours for both the 85°C and 95°C aging tests. The OIT of the lab processed new formula samples mirrored this behavior as shown in Figure 10, with the OIT reaching zero after approximately 164 hours of exposure.

Figure 9. Core OIT at 180°C of new formula after aging at 95°C/5 ppm Cl.

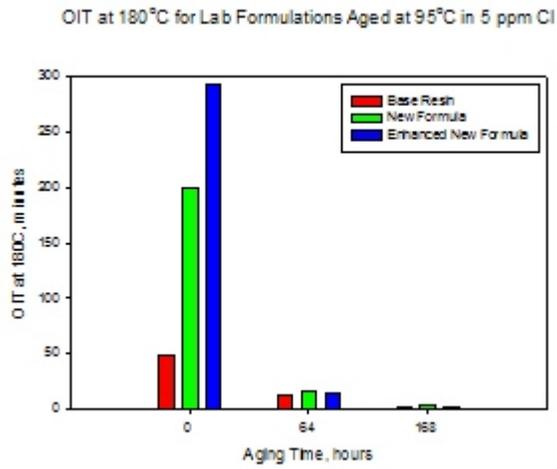
Figure 10. Core OIT at 180°C of lab processed new formula after aging at 95°C/5 ppm Cl

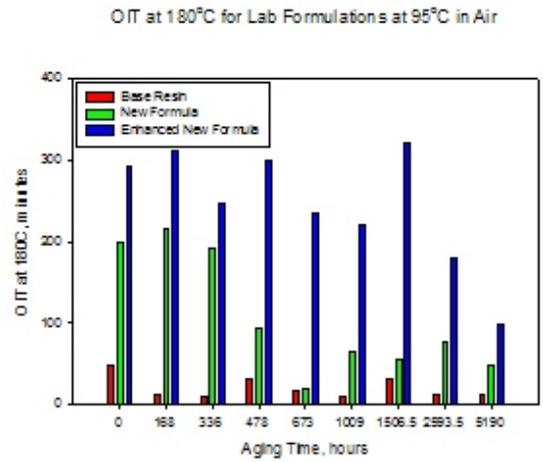
Oven aging was also performed on the lab-compounded samples of the new formulation and enhanced formulation, along with the base resin to compare to the aging in hot chlorinated water. Figure 12 shows the OIT results after oven aging. The oven aging at 95°C showed small, steady decreases in OIT during the more than 5000-hour exposure. No oxidation was detected at the part surface after this aging in air.

Figure 12. . OIT at 180°C of new and enhanced formulas after oven aging at 95°C.

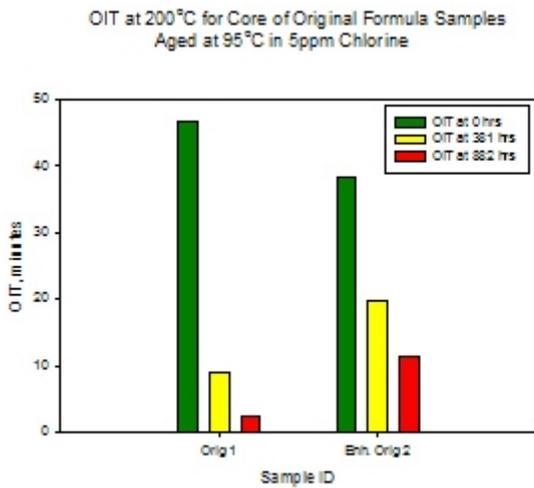
The OIT for the original formula samples was measured at 200°C in order to cut the test times to an hour or less. The OIT at 180°C was several hours for these original formula samples, clearly much longer than that of the new formula. Figure 11 shows the 200°C OIT results at 95°C/5 ppm Cl.

Figure 11. Core OIT at 200°C of original formula aged at 95°C/5 ppm Cl
